INFRARED THERMOGRAPHIC SURVEY

ANYTHING PRODUCTS, INC.

Survey Performed
April 7, 2009

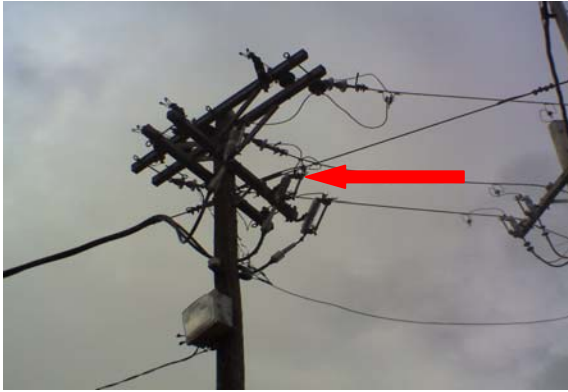
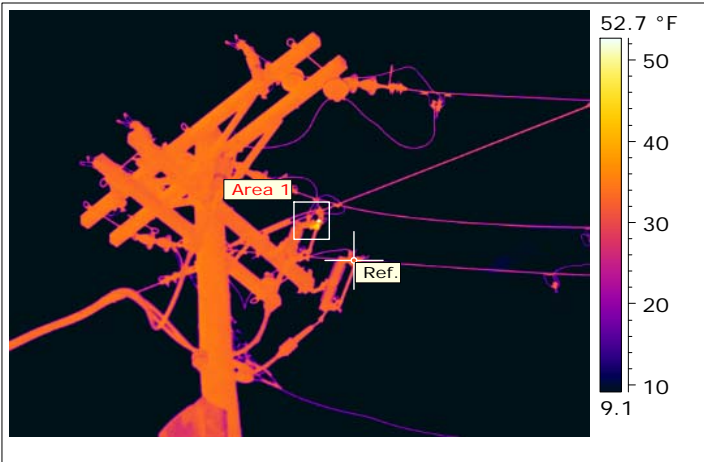
| Equipment ID | Center Drop-out Fuse |

CATEGORY SEVERE

| Ref. Temperature | 33.5 °F |
| Area 1 Max. Temperature | 59.7 °F |
| Area 1: Temp. Rise | 26.2 °F |

*Failure of this fuse would result in a forced outage for half of the plant's production and could possibly damage some three phase equipment.

Contact the local utility to investigate and repair the fuse connection. The actual temperature of the connection is higher than what was measured due to the cold and windy conditions during the inspection.

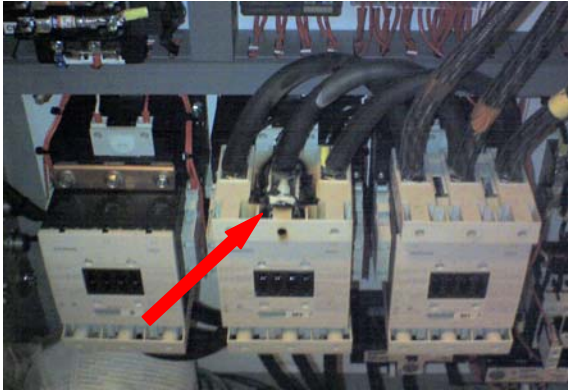
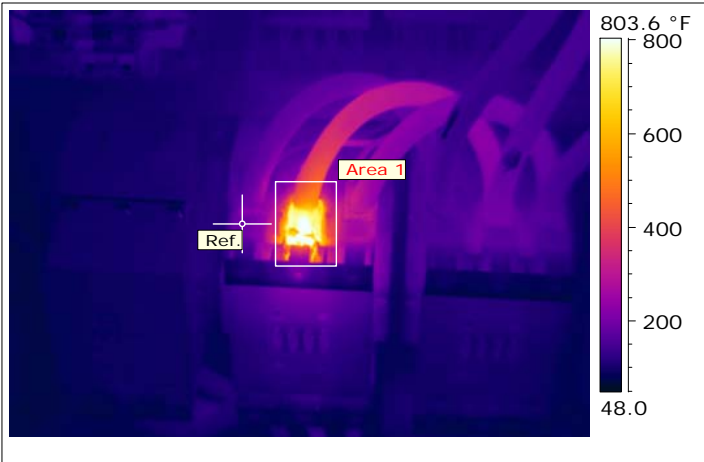
| CATEGORY | CRITICAL |
|---|---|
| Equipment ID | M3 Starter |

| CATEGORY | CRITICAL |

| Ref. Temperature | 189.7 °F |
| Area 1 Max. Temperature | 915.2 °F |
| Area 1: Temp. Rise | 725.5 °F |

The starter is visibly damaged due to the extreme temperature and is no longer repairable. Mr. Johnson (Maintenance Manager) immediately contacted the manufacturer to have a replacement starter delivered the next day.
 *This is rated as "CRITICAL" due to the high temperature and because the location only has a 150 HP compressor as a backup. The 150 HP cannot supply enough air to operate the plant.

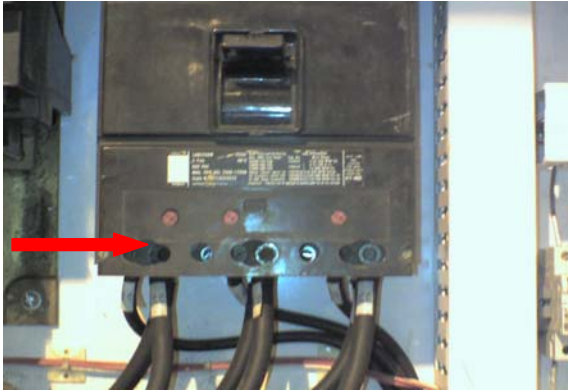
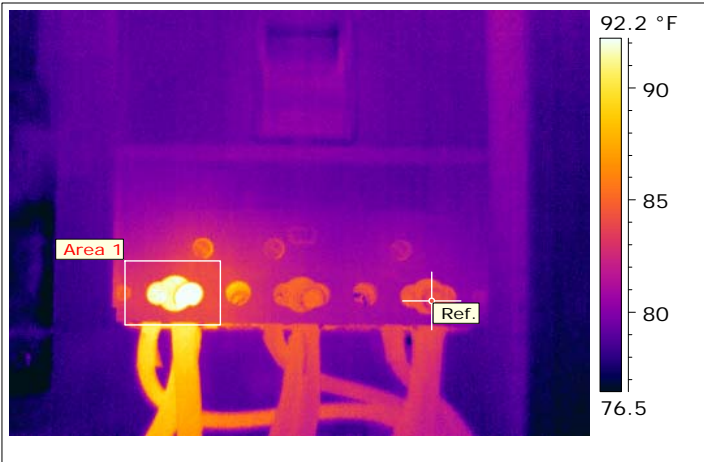
| CATEGORY | ALERT |
|---|---|
| Equipment ID | Main Breaker |

| CATEGORY | ALERT |

| Ref. Temperature | 84.4 °F |
| Area 1 Max. Temperature | 93.7 °F |
| Area 1: Temp. Rise | 9.3 °F |

Disassemble, clean, and remake the lug connection. Torque the lug to OEM specifications.

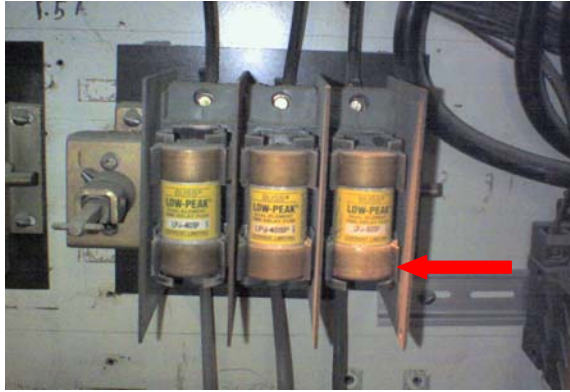
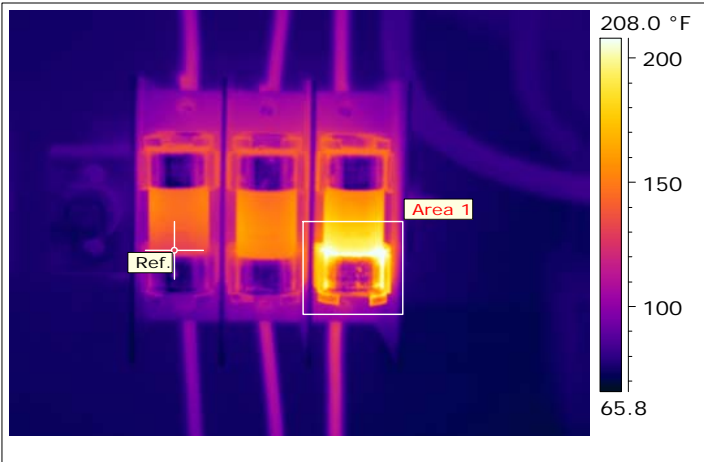
| CATEGORY | ALERT |
|---|---|
| Equipment ID | Main Disconnect |

| CATEGORY | ALERT |

| Ref. Temperature | 129.7 °F |
| Area 1 Max. Temperature | 223.3 °F |
| Area 1: Temp. Rise | 93.6 °F |

Replace the fuse and fuse clip. Due to the high temperature the metal hardware has annealed and is no longer repairable.

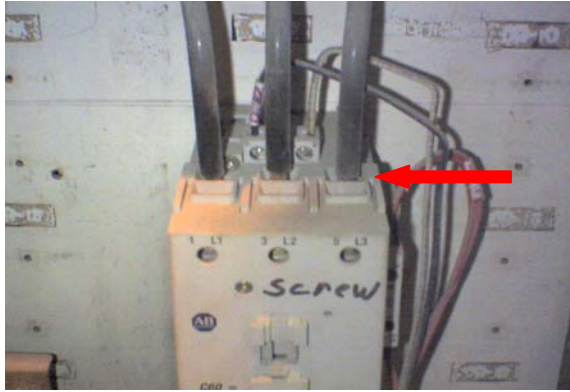
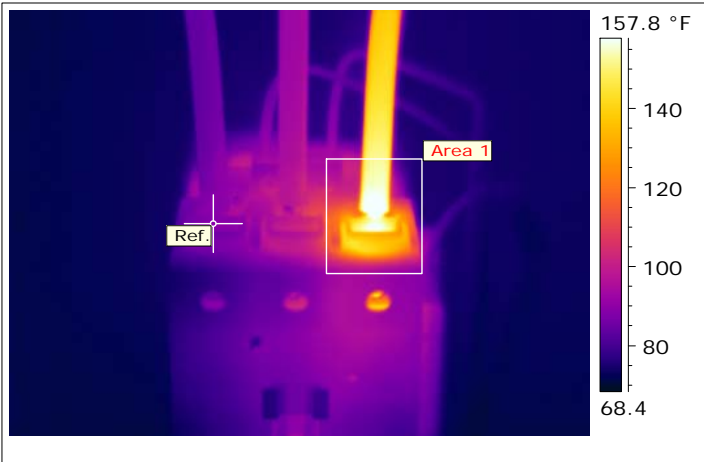
| CATEGORY | ALERT |
|---|---|
| Equipment ID | Screw Starter |

| CATEGORY | ALERT |

| Ref. Temperature | 89.8 °F |
| Area 1 Max. Temperature | 166.3 °F |
| Area 1: Temp. Rise | 76.5 °F |

The connection should be disassembled, cleaned, inspected for damage and repaired as necessary. Reassemble and properly torque fasteners according to the manufacturer's specifications, using new hardware as required. The plant has a spare starter on site.

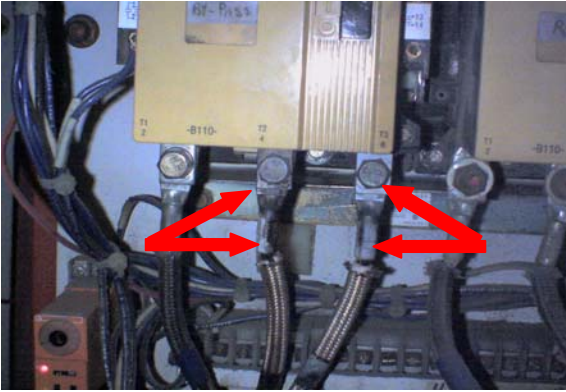
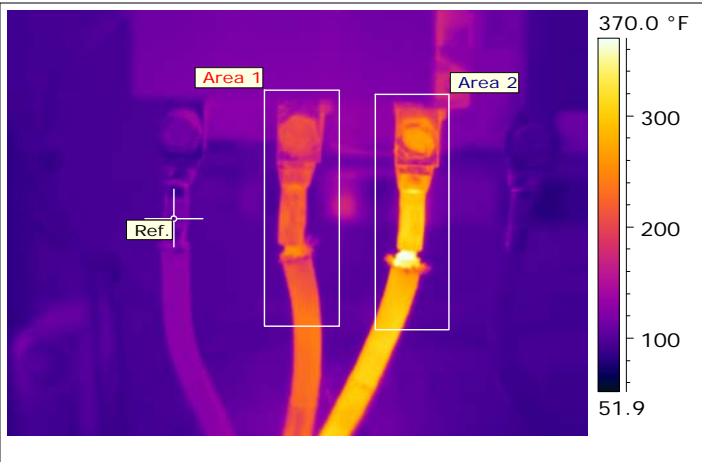
| Equipment ID | By-Pass Starter |

CATEGORY SEVERE

| Ref. Temperature | 98.8 °F |
| Area 1 Max. Temperature | 258.1 °F |
| Area 2 Max. Temperature | 426.4 °F |
| Area 1: Temp. Rise | 159.3 °F |
| Area 2: Temp. Rise | 327.6 °F |

The problem appears to be at the bolted connections or the crimp connectors. Replace all damaged or discolored hardware and cut back the wires to sound conductor.
